Manhole Inspection Summary

Manhole # S41Y1_025MH

Insp Date: **4/17/08 11:06 AM**

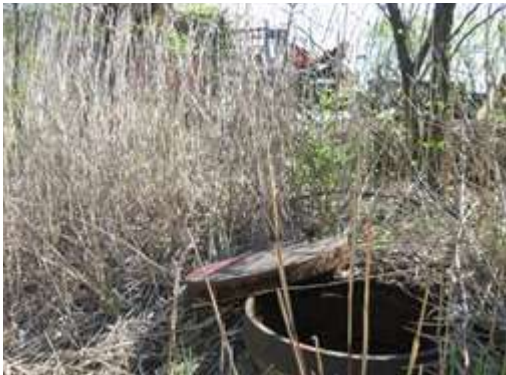
Location View

3500 9th St.

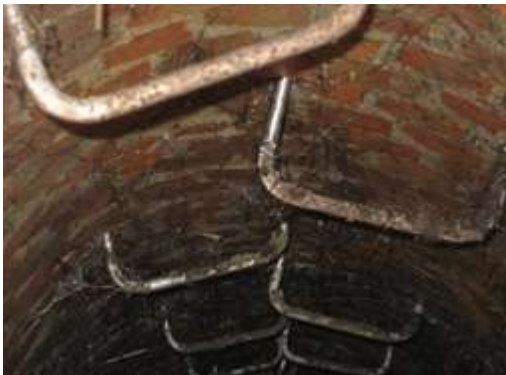
Steps Count: **11** Missing: **0** ☐ Corroded

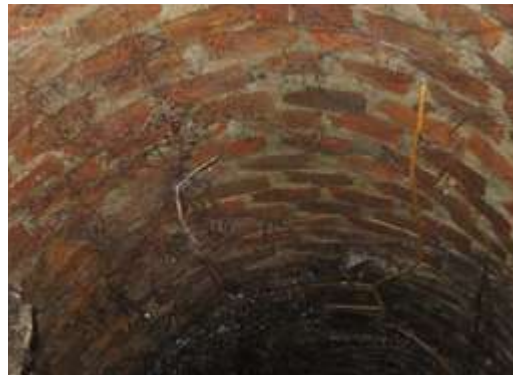
Defect 1

Condition: ☐ Sound ☐ Cracked ☒ **Root Intrusion** ☐ Loose Brick ☐ Deteriorated

Infiltration: ☐ None ☐ Joint ☐ Cracks ☐ Mortar ☒ **Roots** ☒ **Wall**

Root intrusion

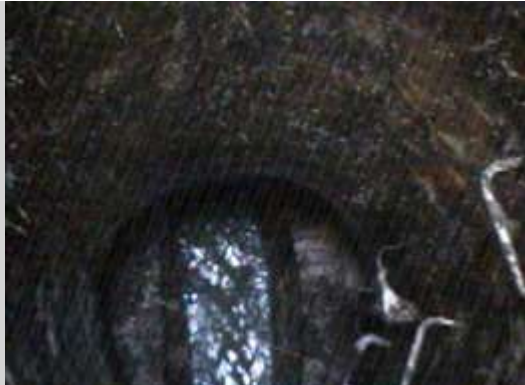
12 O'Clock Outflow

24 in. Circular Gravity Sewer
Pipe Out @ 12 O'Clock

Pipe Height: **24** (in.) Rod and Bar (Angled)
Pipe Material: **Clay** ☐ Pipe Lined
Invert Depth: **20.60** (ft.) Flow Characteristics: **Fast**
Deposits: ☒ None ☐ Mud ☐ Sludge ☐ Debris ☐ Grease
Silt Depth: (in.) Deposits Extent:
Infiltration: **None** Pipe Seal Cond: **Unknown**

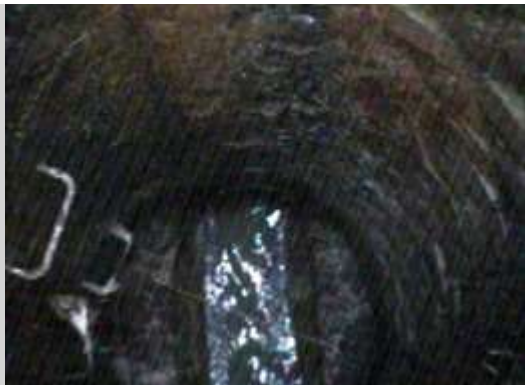
6 O'Clock Inflow

24 in. Circular Gravity Sewer
Pipe In @ 6 O'Clock

Pipe Height: **24** (in.) Rod and Bar (Angled)
Pipe Material: **Clay** ☐ Pipe Lined
Invert Depth: **20.14** (ft.) Flow Characteristics: **Fast**
Deposits: ☒ None ☐ Mud ☐ Sludge ☐ Debris ☐ Grease
Silt Depth: (in.) Deposits Extent:
Infiltration: **None** Pipe Seal Cond: **Unknown**
